Polymer coating application increases durability and reliability of ESP's components.

Полимерное покрытие повышает надежность и долговечность погружных ЭЦН.

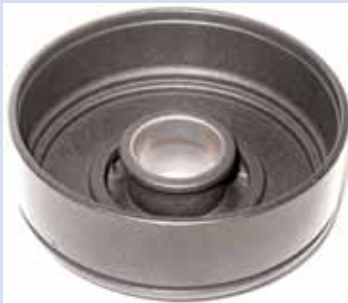
- Showing polymer coated diffuser and impeller.
- Вид направляющего аппарата и рабочего колеса с покрытием.

Hydroabrasive testing has discovered the minimal value of the coating deterioration on the outer surfaces of the diffuser casing and impeller disks. The area with the increased surface deterioration is the inside surface of diffuser casing and inside surface of the upper disc of impeller covers. This suggests that the coating thickness in the said areas should be no less than 100 micrometers. The coating formed on the surface of metalware is not wettable by saline solutions, highly resistant to aggressive chemical mediums, highly heat-resistant (long-term operation temperature of up to 260 °C), extremely strong and tough.

Гидроабразивные испытания выявили минимальную величину износа покрытия на внешних поверхностях дисков НА и РК. Области с повышенным износом покрытия являются внутренняя поверхность обоймы НА и внутренняя поверхность верхнего диска РК, из чего следует, что толщина покрытия в данных местах должна быть не ниже 100 мкм.
